Reliability Based Vegetation Management Through Intelligent System Monitoring

Final Project Report

Power Systems Engineering Research Center

PSERC Publication 07-31

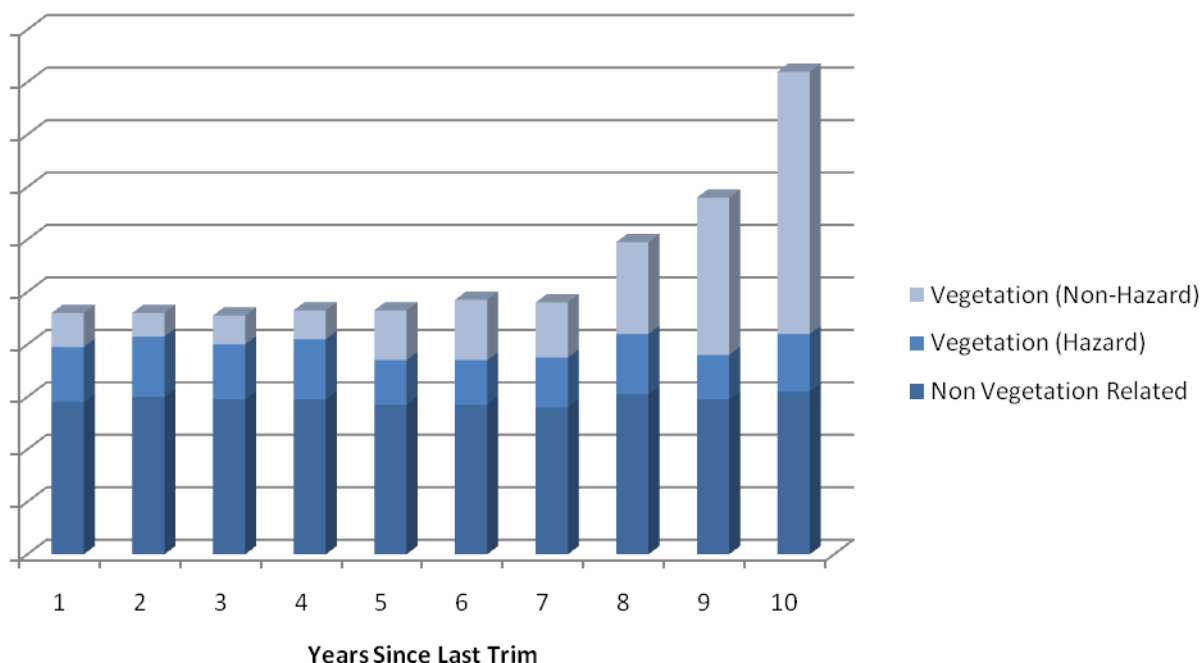
Figure 1.1: Hypothetical Representation of Outages by Cause as a Function of Time

Figure 1.1 is a hypothetical example of how vegetation-related outages may grow over time. In this example, non-vegetation-related outages and outages caused by “hazard trees” which exist outside the utility’s right of way remain relatively constant from year to year. Vegetation-related outages not caused by hazard trees also remain relatively constant for the first few years, but begin to increase as time goes on. This is more clear in Figure 1.2 where the non-vegetation and hazard-related vegetation components have been removed. In this example, the non-hazard component of vegetation-related outages remains low and relatively constant for five years after the circuit is trimmed. After five years, however, vegetation has encroached heavily on the system, and reliability will fall to unacceptable levels unless corrective action is taken.

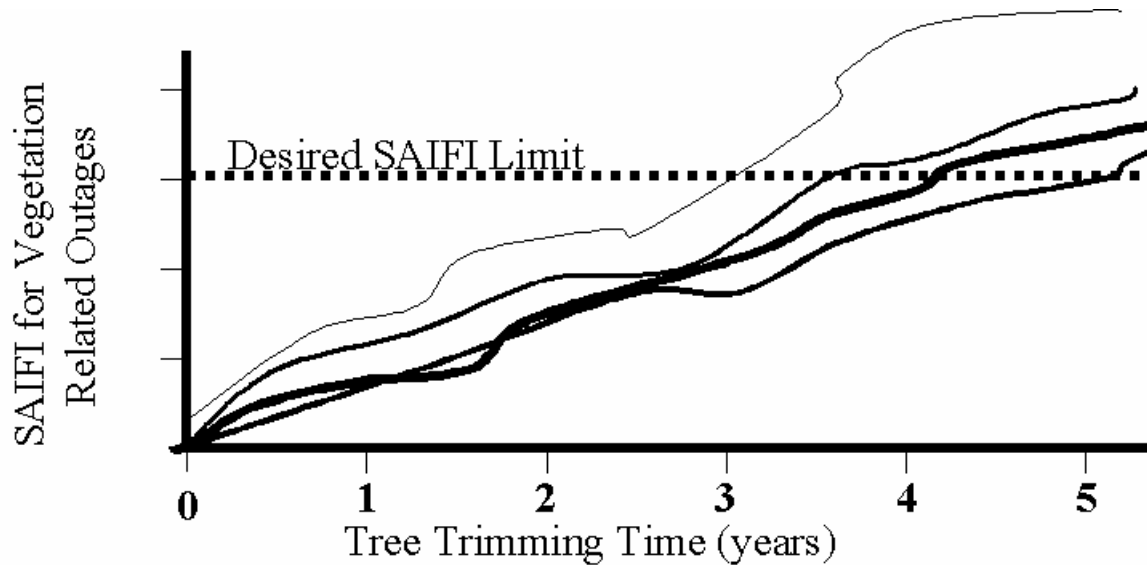
Figure 1.3: Vegetation-related Reliability Over Time

Figure 1.3 is a hypothetical illustration of how the vegetation-related component of SAIFI for individual distribution circuits can vary widely. In this example, reliability levels for four feeders are shown as a function of time. To achieve the same level of vegetation-related SAIFI, one feeder should be trimmed after only three years, whereas another feeder could be trimmed every five years with the same level of reliability. Suppose the feeders in the above example were trimmed every four years. Some feeders (the highest two lines) needed to be trimmed after three and three and a half years respectively. In this example, these feeders would have an unacceptably high SAIFI, as they were not trimmed soon enough. One feeder, on the other hand, should be trimmed after five years, and thus would be trimmed one year early. While this feeder would not suffer adversely in terms of reliability the additional cost of more frequent trimming would be a waste of resources, with little or no benefit to customer reliability.

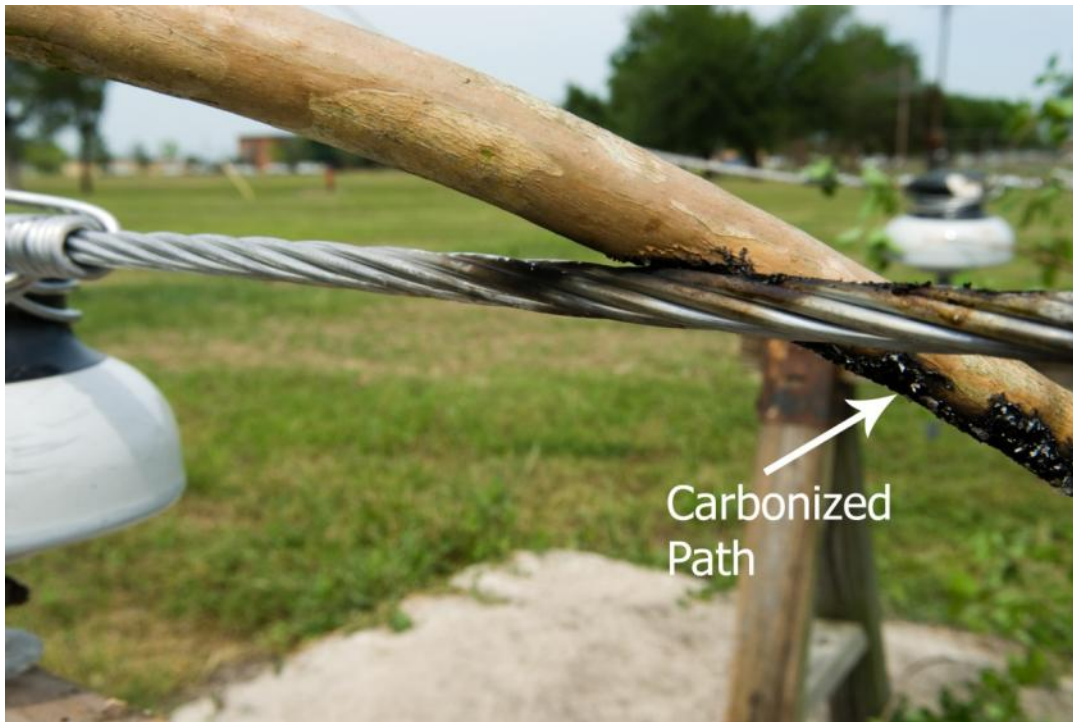
Figure 2.1: Tree Branch Following Flashover, Carbonized Path Visible on Right

This is illustrated in Figure 2.1 where the carbonized path can be seen starting from the line and proceeding to the right in the direction of the other conductor. It is important to recognize this process occurs at each end of the conductor, with each path proceeding toward the center of the branch.

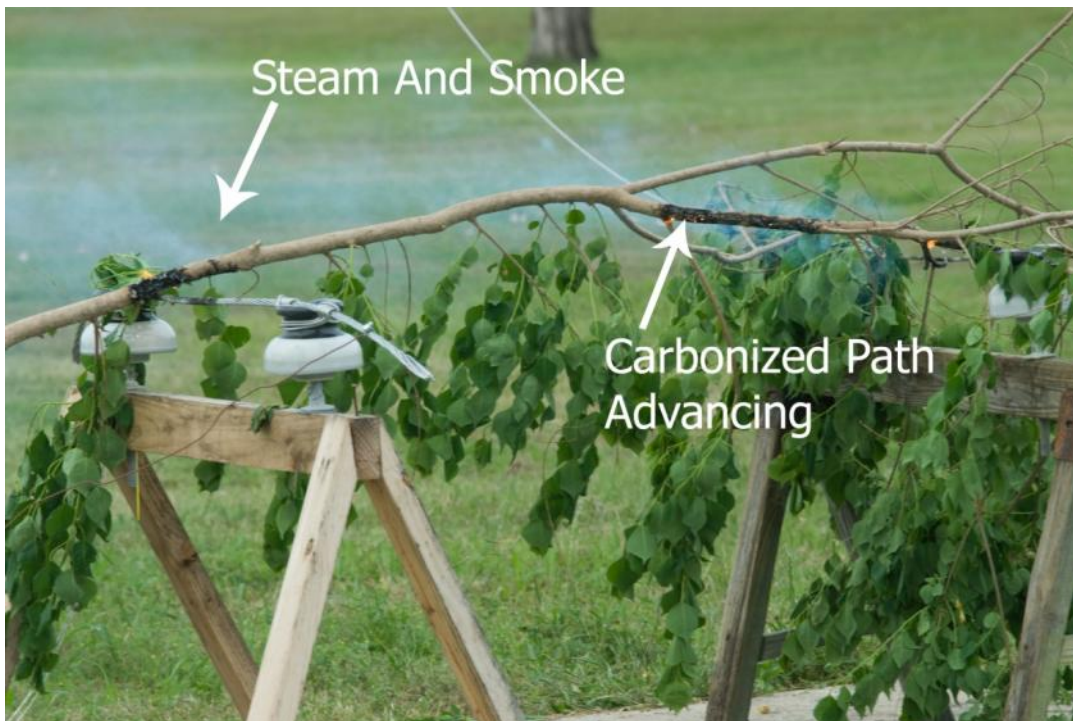
Figure 2.2: Carbonized Path Progressing from Both Contact Points

These paths proceed only when enough moisture content is present within the branch. Field tests indicated that a dry, dead branch does not readily form carbonized paths even after tens of minutes of solid contact between the phase conductor and neutral. Figure 2.2 shows the carbonized path progressing along a branch between phase and neutral conductors.

As the carbonized path progresses, it may progress on the surface as shown in Figure 2.2, or under the bark, as shown in Figure 2.3. The photo shows steam and smoke escaping through holes in the bark as the carbonized path burns and dehydrates the wood underneath.

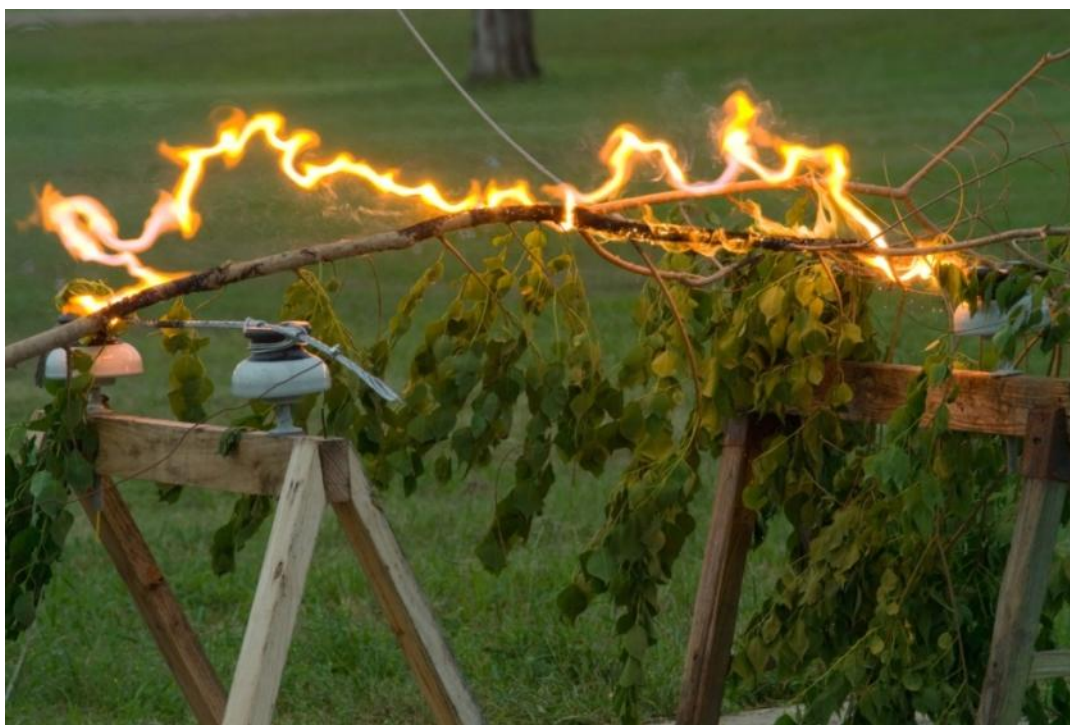
Figure 2.4: Formation of Arc Between Lines

Figure 2.4 clearly shows the electric arc struck between the two power lines. The arc forms initially along the carbonized path, but quickly transfers into the plasma immediately surrounding the branch. One can note how the arc wraps around the center of the branch in Figure 2.4. As is common with arcing faults of this nature, the heat of the plasma causes it to rise into the air which increases the arc length, also increasing its impedance. At some point, the voltage between the lines will no longer be able to sustain the arc through the plasma, and it will extinguish. The carbonized path remains along the branch, however, and another arc is reenergized along the path again, repeating the process. Alternatively, the branch may separate from one or both of the contact points, temporarily removing the fault from the system. This process may repeat until a protection device is operated or until a line burns down. Electrical effects from this interaction may be measurable at a distant substation, as will be discussed later in the text.

While the paths burn toward the center, the tree branch serves essentially as a high-impedance conductor for low-level fault current. Significant heat, burning, and steam may be produced while the fault is drawing only an ampere or less of current. When the two paths meet in the middle, the high-impedance path gives way to a low-impedance path, and a high-current event occurs, as shown in Figure 2.4.

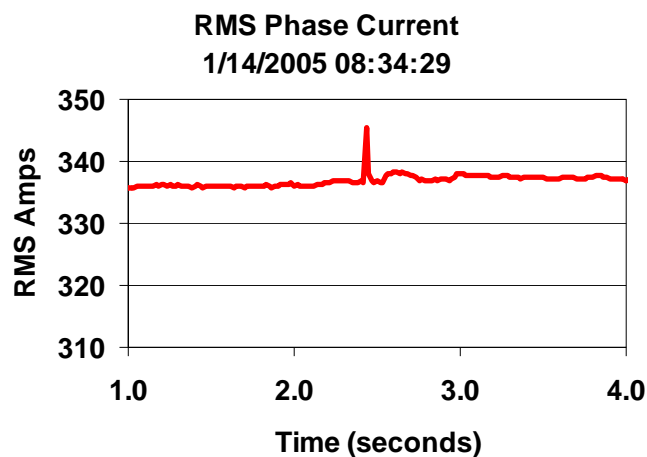
Figure 3.2: RMS Phase Current for Incipient Failure

The waveforms shown below illustrate one measured episode of an incipient vegetation-related failure. In Figure 3.2, a “spike” in RMS current is visible around 2.45 seconds. This and all other DFA-measured events record current and voltage signals at the substation. Therefore the measured waveforms include the normal load on the feeder, in addition to any current drawn by vegetation contactor other anomalies. This spike momentarily adds about ten amps to the 335 amps of current drawn by normal loads on the monitored feeder. The utility company on whose system this occurred later determined that the cause of this spike was a tree limb contacting overhead, open-wire service conductors. The instantaneous phase current in Figure 3.3 provides more detail about the shape of the waveforms involved. The third positive current peak in the waveform is slightly larger than the other current peaks. This slight increase is the only sign that the tree contact occurred, and it is barely recognizable over the normal load current present during the rest of the illustrated time period.

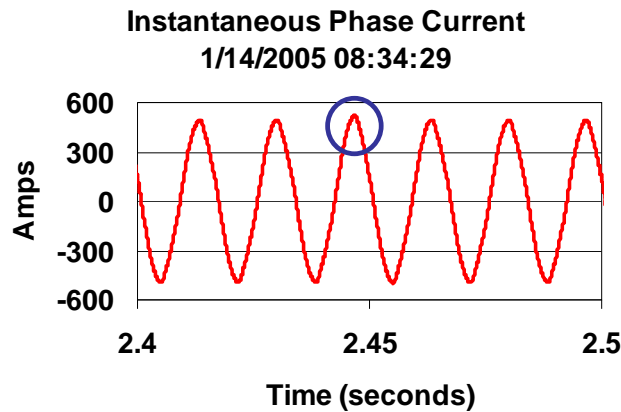
Figure 3.3: Instantaneous Phase Current for Incipient Failure

Instrumentation at this location recorded several dozen instances of nearly identical waveforms over an eight-day period. Coincident with episodes on the eighth day was a customer service call that reported visible arcing in the customer's overhead service. The utility company removed the intrusion and the measured instances ceased. Interestingly, the utility looked at weather patterns during this eight-day period and determined that the times at which the measured episodes occurred correlated with periods of rainfall.

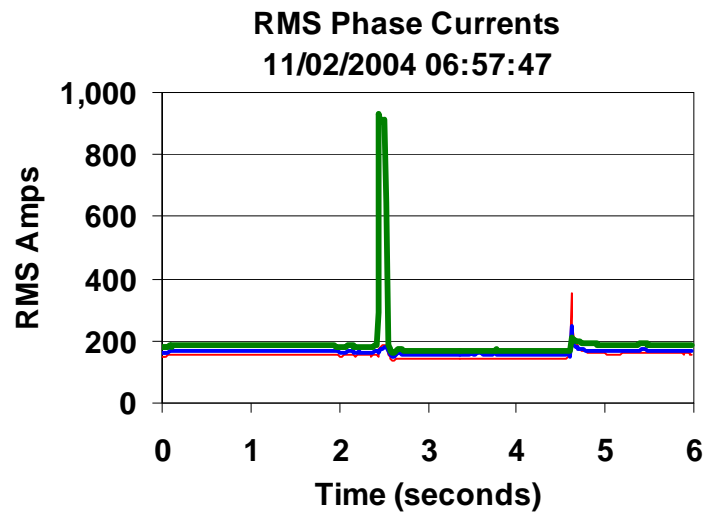
Figure 3.4: RMS Phase Current for Vegetation Outage

The distributed data collection system also has measured several examples of tree contacts that have become severe enough to cause voltage sags, momentary interruptions, and sustained outages. The figures shown below illustrate the first in a series of faults, voltage dips, and interruptions that eventually caused a burned-down line and a sustained outage. The Figure 3.4 illustrates the RMS currents measured at the substation. There were slightly less than 200 amps of load current on each phase prior to the fault. The fault, which occurred at about 2.4 seconds in the figure, drew additional current of about 700 amps, resulting in an instantaneous value of around 900 amps on the affected phase. This was sufficient to operate an overcurrent protective device, a three-phase poletop recloser located between the substation and the fault point. This temporarily cleared the fault by opening the circuit for approximately two seconds, long enough for the branch to lose intimate contact with the overhead line. After closing back in, service was restored to downstream customers, at least temporarily. The Figure 3.5 illustrates the voltage dip that all customers fed by this substation experienced as a result of the momentary fault. Those customers downstream of the recloser experienced a total interruption for the recloser's two-second open interval, a clear power quality concern in the modern age of electronics in every home and business.

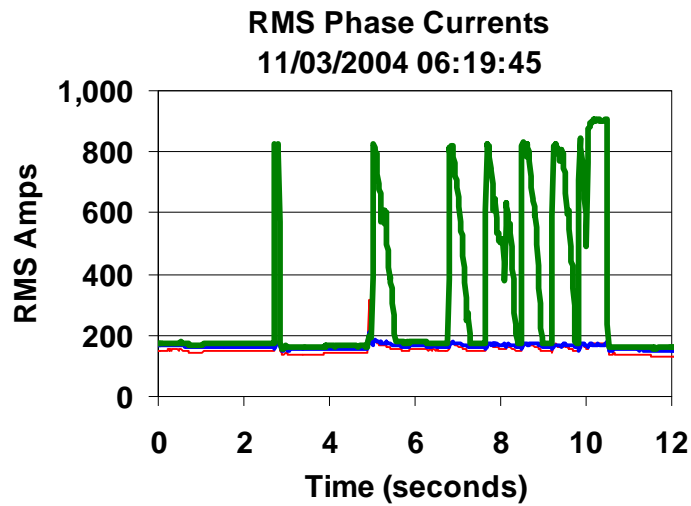
Figure 3.6: RMS Phase Currents for Final Failure in Vegetation Outage

Each instance of this fault also caused arc damage to the conductors at the point of the fault. Figure 3.6 and Figure 3.7 illustrates the RMS currents and voltages recorded during the final instance of the fault. In this instance, the limb made more persistent contact with the line conductors, causing repetitive overcurrents. This resulted in the line burning down at the point of contact, which left 140 customers without power for 62 minutes.

When the utility responded to the resulting customer lights-out calls, they found that a tree limb had fallen on the line without immediately breaking the line. The line was constructed with a phase conductor on top of the poles and a neutral conductor several feet below it on the same poles. A fork in the tree limb caused the limb to hang on the phase conductor. The weight of the limb pulled the phase conductor down closer than normal to the neutral conductor. The tree limb contacted the phase conductor continuously and the neutral conductor intermittently. This casual contact caused the periodic flashovers that resulted in the overcurrents and interruptions and in the cumulative damage that eventually brought the line down.

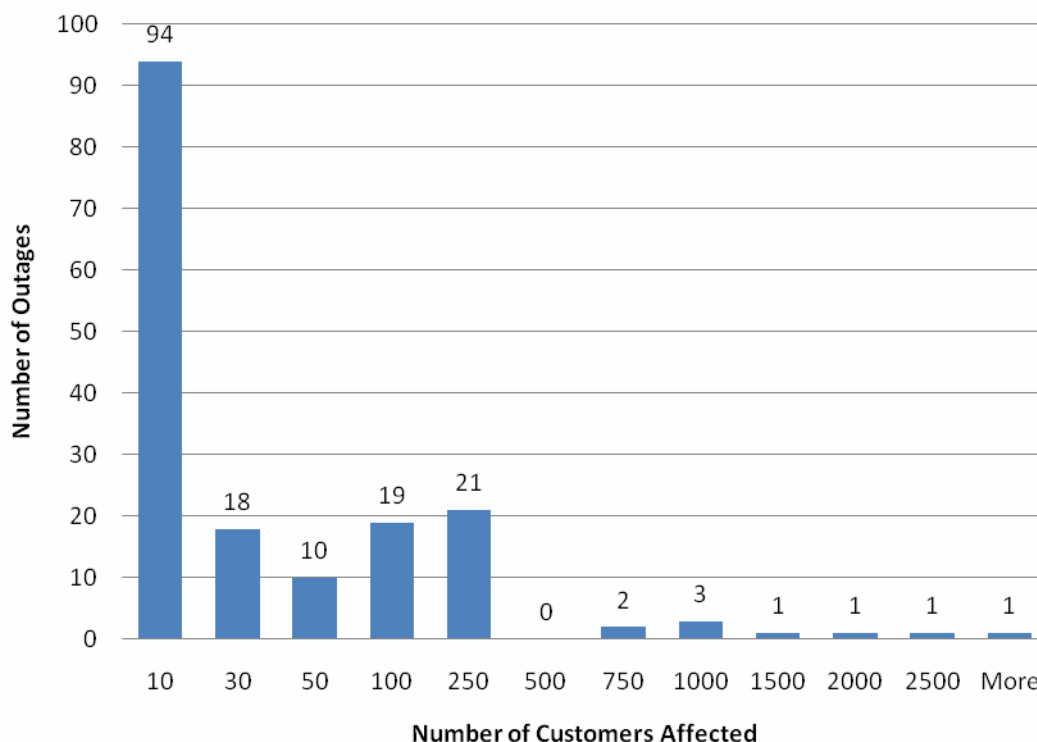
Figure 5.1: Number of Affected Customers Per Outage at Monitored Substation, 2000-2006

A more detailed breakdown of the number of affected customers yields additional relevant data. Figure 5.1 shows a histogram of the numbers of customers affected per outage on the substation from 2000-2006. It is clear from the histogram that the vast majority of vegetation-related outages affect relatively few customers, with approximately 55% of outages affecting ten customers or less. Second, it is equally clear that while the majority of vegetation-related outages affect relatively few people, there are outages which affect significantly more people. During the observed time period, a vegetation-related outage disrupted service to over 1000 customers at least once per year on average.

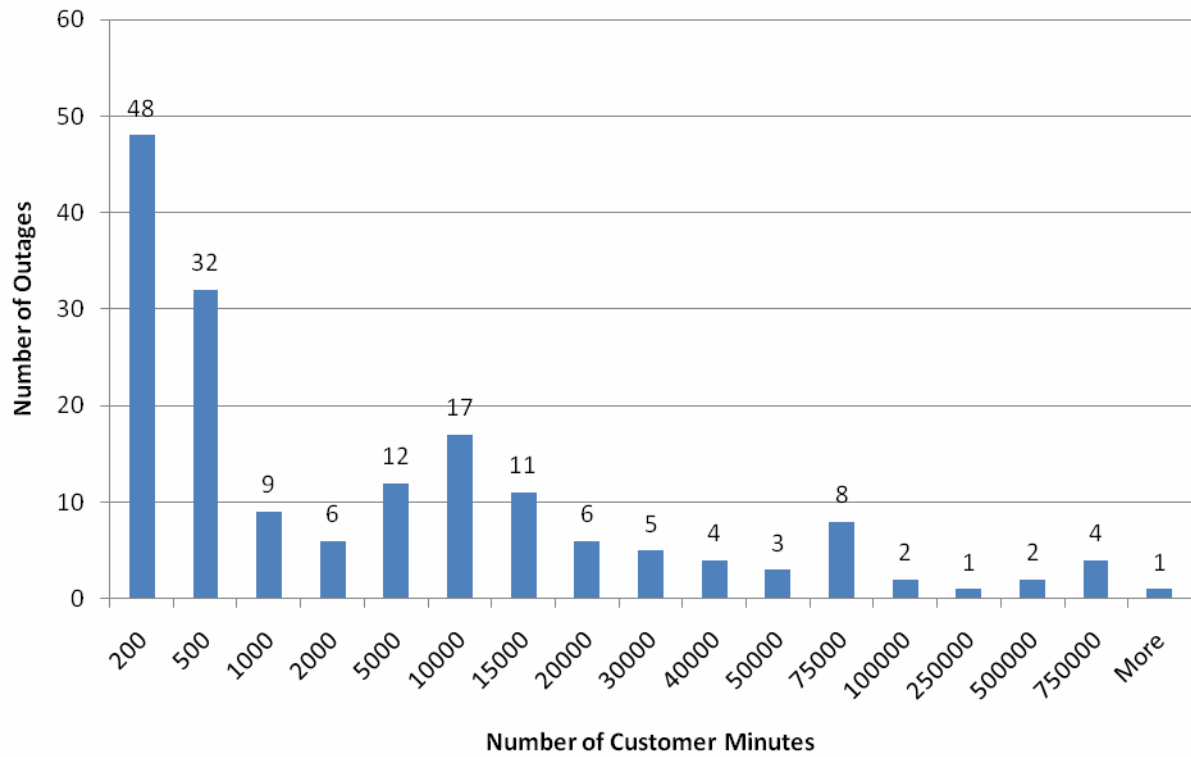
Figure 5.2: Customer Minutes Per Outage at Monitored Substation, 2000-2006

This trend becomes more apparent when viewing a histogram of customer minutes, as shown in Figure 5.2. Again, a significant number of vegetation-related outages are relatively minor, but incidents do have the potential to have a major impact on reliability metrics. In fact, of the top ten disruptions (in terms of customer minutes) at the substation between 2000-2006, three were vegetation-related. While vegetation-related outages accounted for 10.5% of outages by number during the observed period, they accounted for 13.9% of customer outage minutes during the same period. If these outage statistics are broken down by year, again the years with the best reliability statistics are 2001 and 2002, the two years immediately before the scheduled trim.

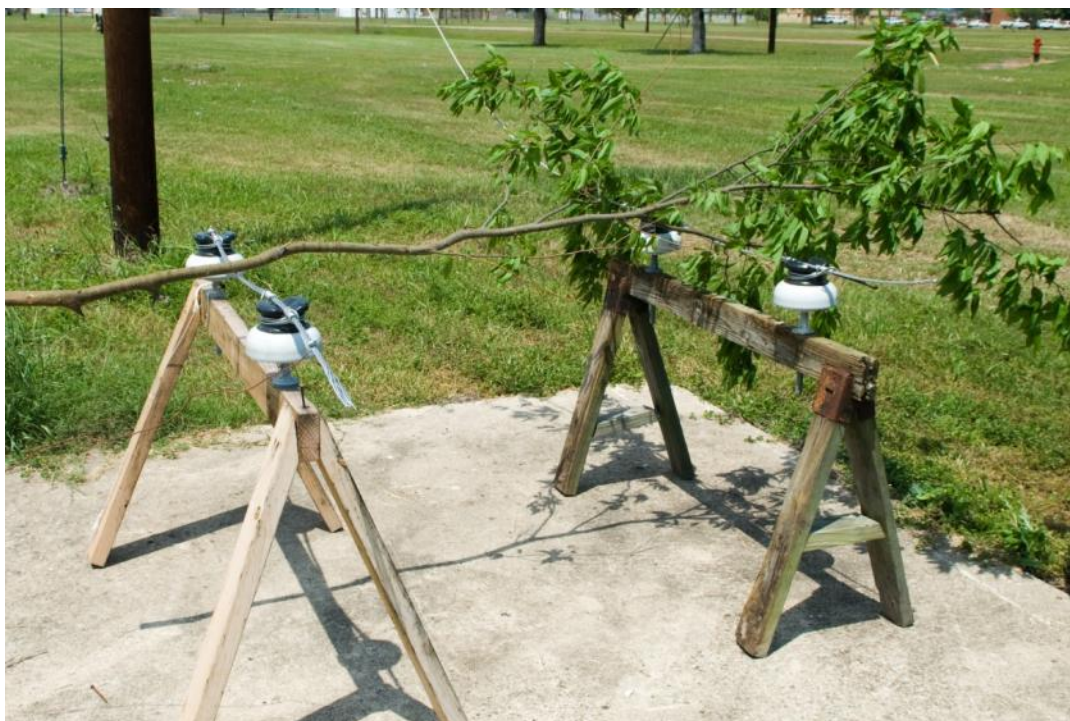
Figure 6.1: Experimental Setup

The general experimental setup, excluding the resistor bank, is shown in Figure 6.1. Branches were laid across the lines, but not attached physically in any way.

After a branch was laid from phase conductor to neutral, linemen would energize the line. Video and still pictures were taken to document the progression of each experimental run.

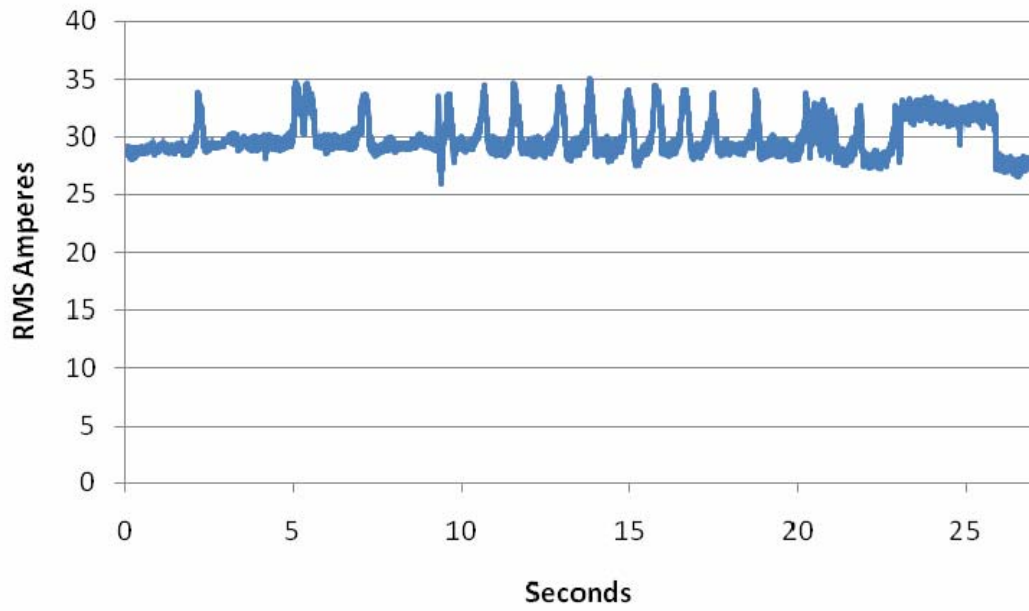
Figure 6.2: Experiment 1 - Neutral Currents

Figure 6.2 shows recorded data from a 27-second period during the fault recorded in Experiment 1. The figure shows RMS neutral current (I_N) calculated at two points per cycle. Each peak seen on the graph corresponds to one instance of a high current event. Each peak is approximately the same height and several have approximately the same profile and duration. The final extended burst can also be seen.

Again, as with previous tests, a carbonized path began to form on the branch immediately after the line was energized and continued for 4 minutes and 55 seconds before the paths met and created a low impedance arc. The tree began a series of arcing which lasted for approximately 18 seconds. During this period of time there were 13 short bursts followed by one extended burst. As with Experiment 1, the short bursts persisted for approximately 15 cycles. The final burst again was extended by a gust of wind, and persisted for approximately 6.5 seconds. Waveforms for the 18 second period are shown in Figure 6.15. As with Experiment 1, the RMS for both the neutral and waveforms with ambient removed are presented. Figure 6.16 presents the final arc burst in greater detail. It is important to note that Figure 6.15 and Figure 6.16 are strikingly similar to Figure 6.2 and Figure 6.3 observed in Experiment 1.

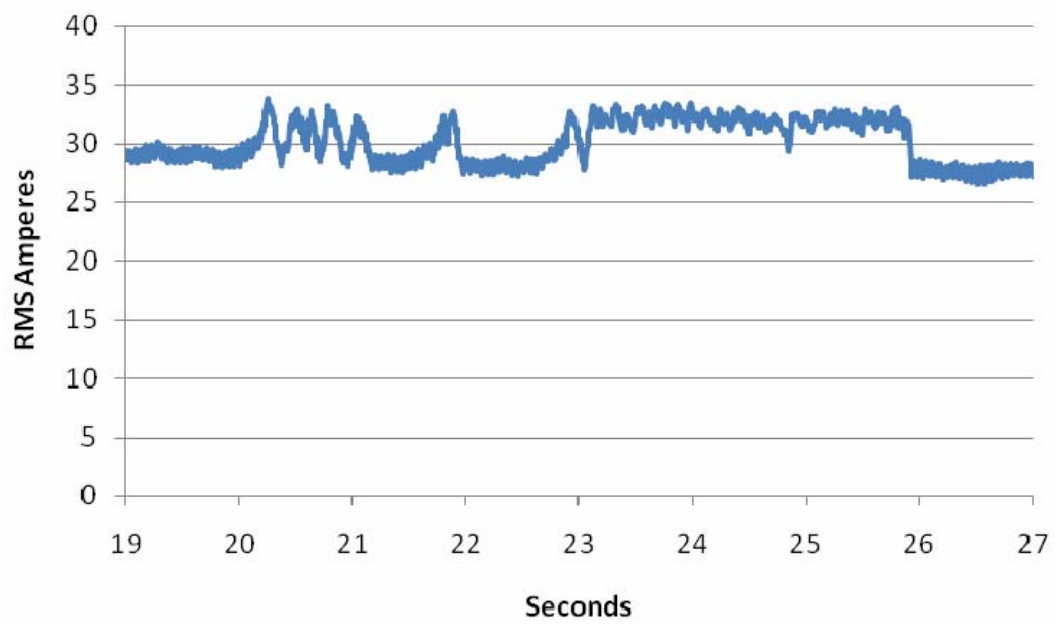
Figure 6.3: Experiment 1 - Detailed View - Final Arc Bursts

Figure 6.3 shows a detailed view of the final burst in Experiment 1. As previously noted, the extended length of this burst was caused by a gust of wind which prevented the arcs from lengthening in their characteristic nature.

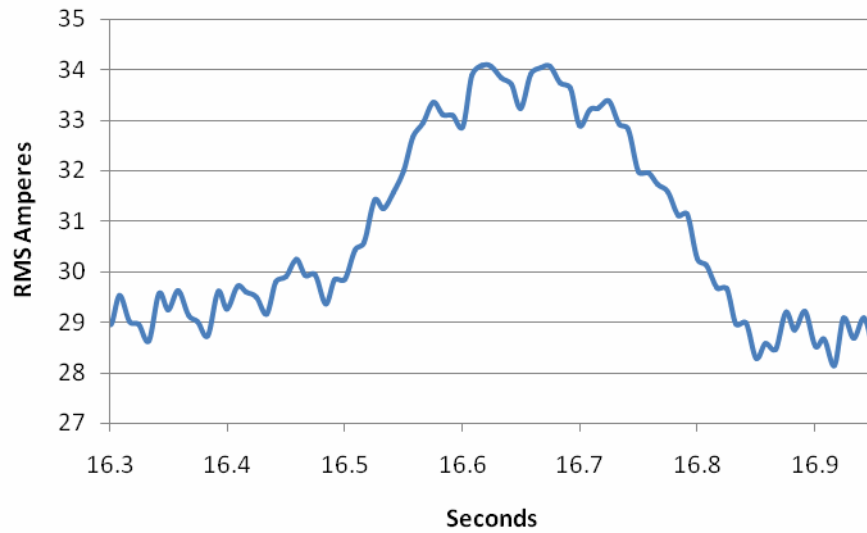
Figure 6.4: Experiment 1 - In RMS, Peak, zoomed in

Figure 6.4 is a detailed view of the RMS of one of the peaks recorded in Figure 6.2. It is important to note that this waveform capture is very similar to waveforms captured in the DFA project.

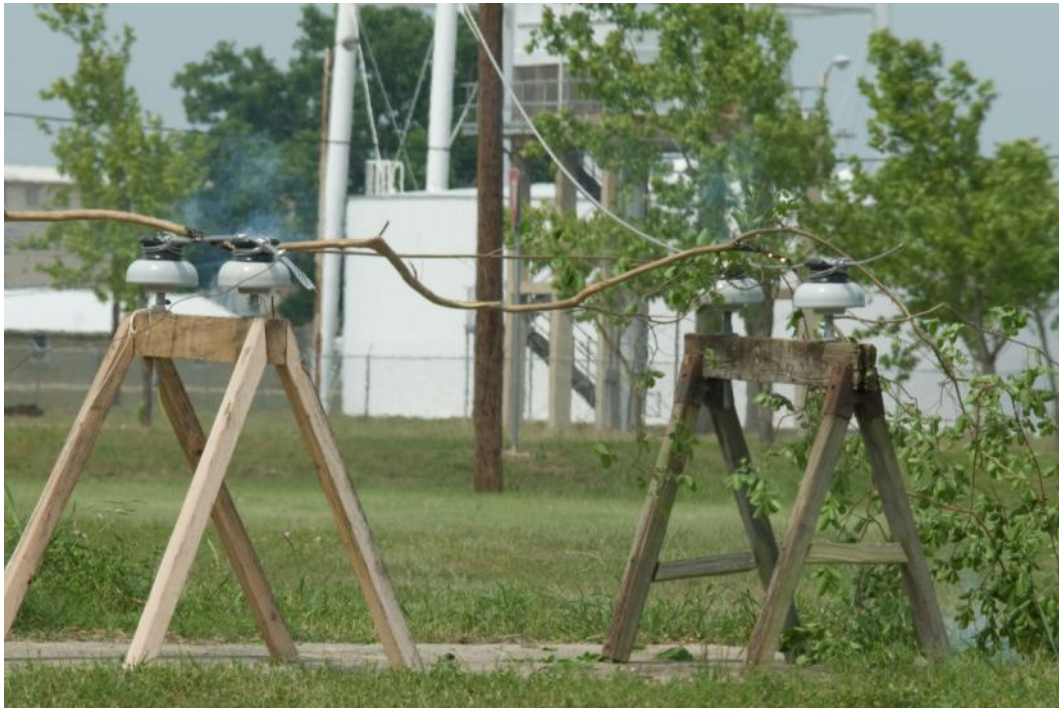
Figure 6.5: Experiment 1 - Crape Myrtle Tree Releasing Smoke and Steam

Figure 6.5, Figure 6.6, and Figure 6.7 show a photographic progression of Experiment 1. In Figure 6.5, the crape myrtle tree producing smoke and steam. One feature of interest in this

photograph is that the branch is contacting ground not only through the neutral conductor, but also through some of the leaves which are touching the ground, as seen on the right side of the photo. This incidental contact quickly burned away after the line was energized. Figure 6.6 shows the typical high current arc formed when the formation of a carbonized path has completed. This particular arc has just formed, and is not particularly long at this point. Figure 6.7 shows the final extended arc burst, and the gusting wind can be observed affecting the arc. The phase and neutral conductors were placed four feet apart, so the initial arc was approximately that length. As the arc plasma rose away from the branch, the arc typically lengthened by several feet before ultimately extinguishing.

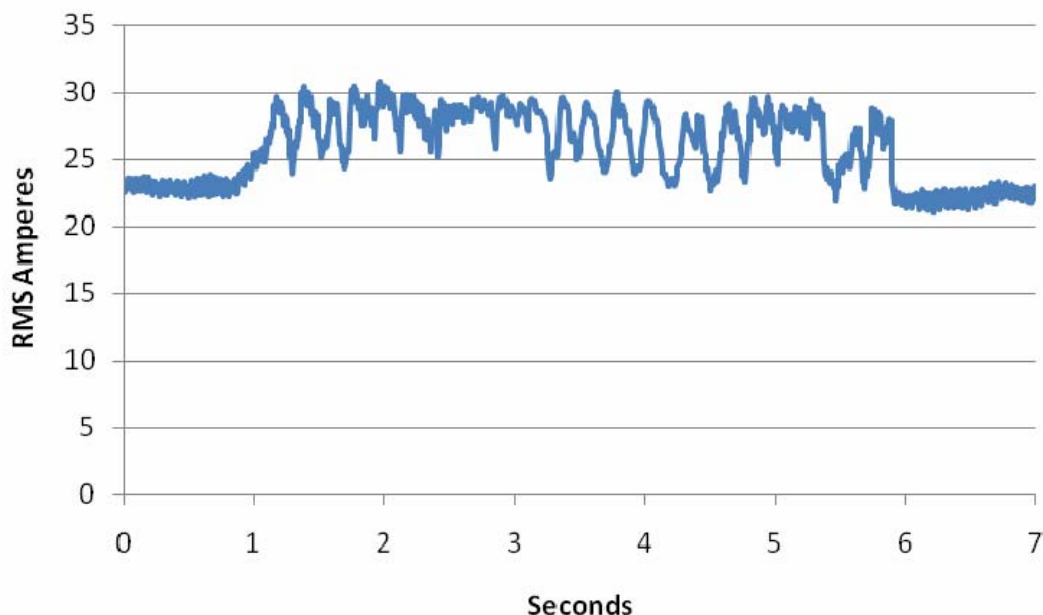
Figure 6.8: Experiment 1 - Currents During First Reenergization

After the extended arc burst operated the 2A fuse, the branch remained intact between the two lines. Researchers decided to reenergize the line without removing the branch to determine whether or not the fault would immediately recur. Figure 6.8 and Figure 6.9 show currents generated after the line was reenergized. The first time the line was reenergized, the faulted condition immediately returned and persisted for approximately five seconds before again operating the 2A fuse. Figure 6.8 shows the RMS for I_N .

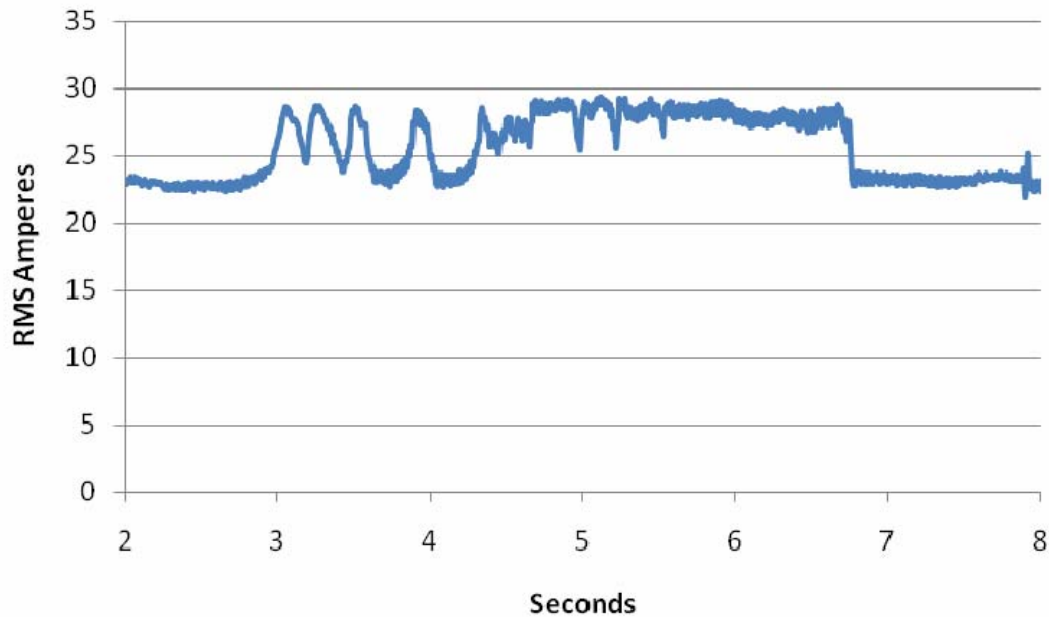
Figure 6.9: Experiment 1 - Currents During Second Reenergization

Researchers again re-fused and reenergized the line without moving the branch. The currents for the second reenergization are shown in Figure 6.9. In this experiment, the faulted condition again returned immediately and persisted for approximately 230 cycles, or just under four seconds before again operating the 2A fuse. It seems likely that the line would have continued to remain in place until it burned free or operated system protective devices.
